**ARMY PRELIMINARY EVALUATION YAH-1R IMPROVED COBRA  
AGILITY AND MANEUVERABILITY HELICOPTER**

USAAEFA PROJECT NO. 74-33

## **FINAL REPORT**

**UNITED STATES ARMY AVIATION ENGINEERING FLIGHT ACTIVITY  
EDWARDS AIR FORCE BASE, CALIFORNIA 93523**

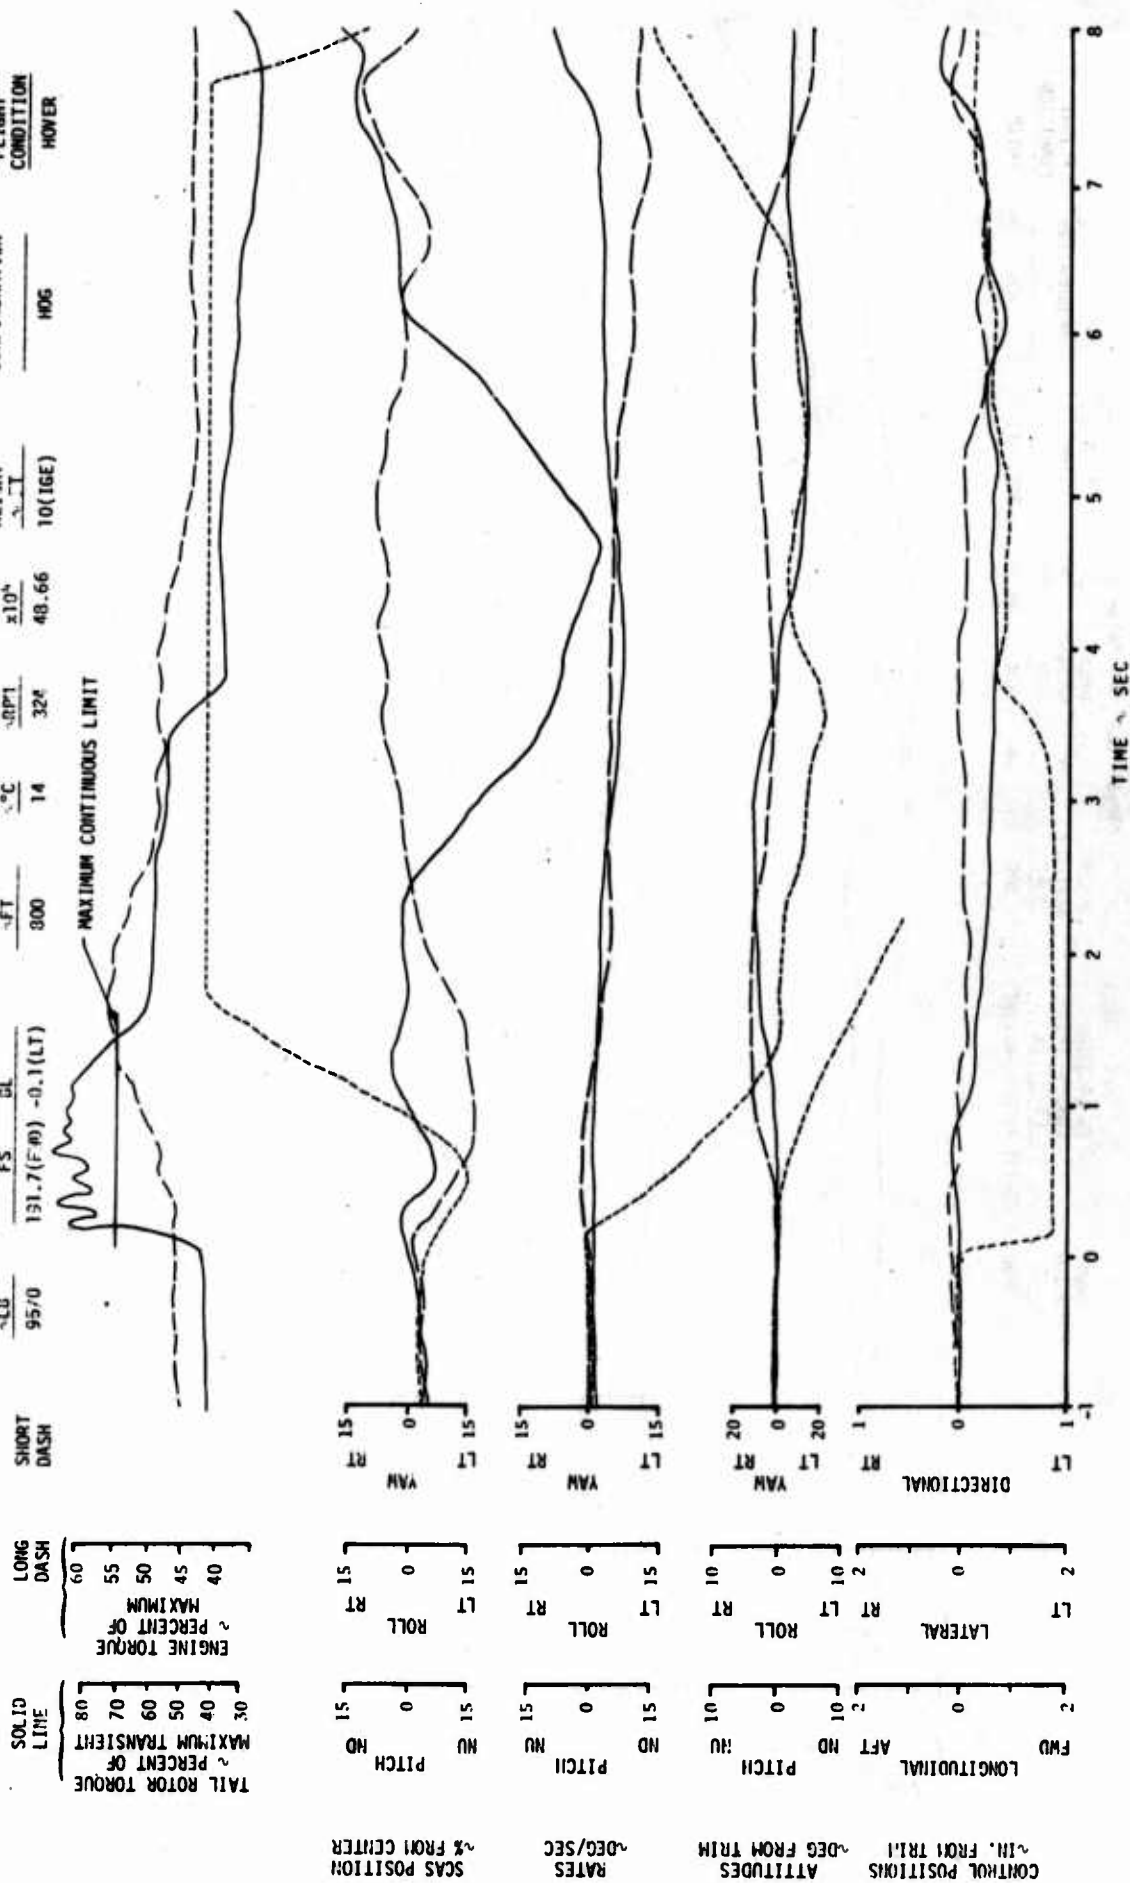
FIGURE 33  
HOVER TURN ARRESTMENT  
YAH-1R USA S/N 70-15936

GROSS WEIGHT ~LB	CG LOCATION LONG FS LAT BL	DENSITY ALTITUDE ~FT	OAT ~°C	ROTOR SPEED ~RPM	C <sub>T</sub> x10 <sup>4</sup>	SKID HEIGHT ~FT	CONFIGURATION	FLIGHT CONDITION
10050	199.4(AFT) -0.1(LT)	20	10	324	49.92	10(IGE)	H06	HOVER

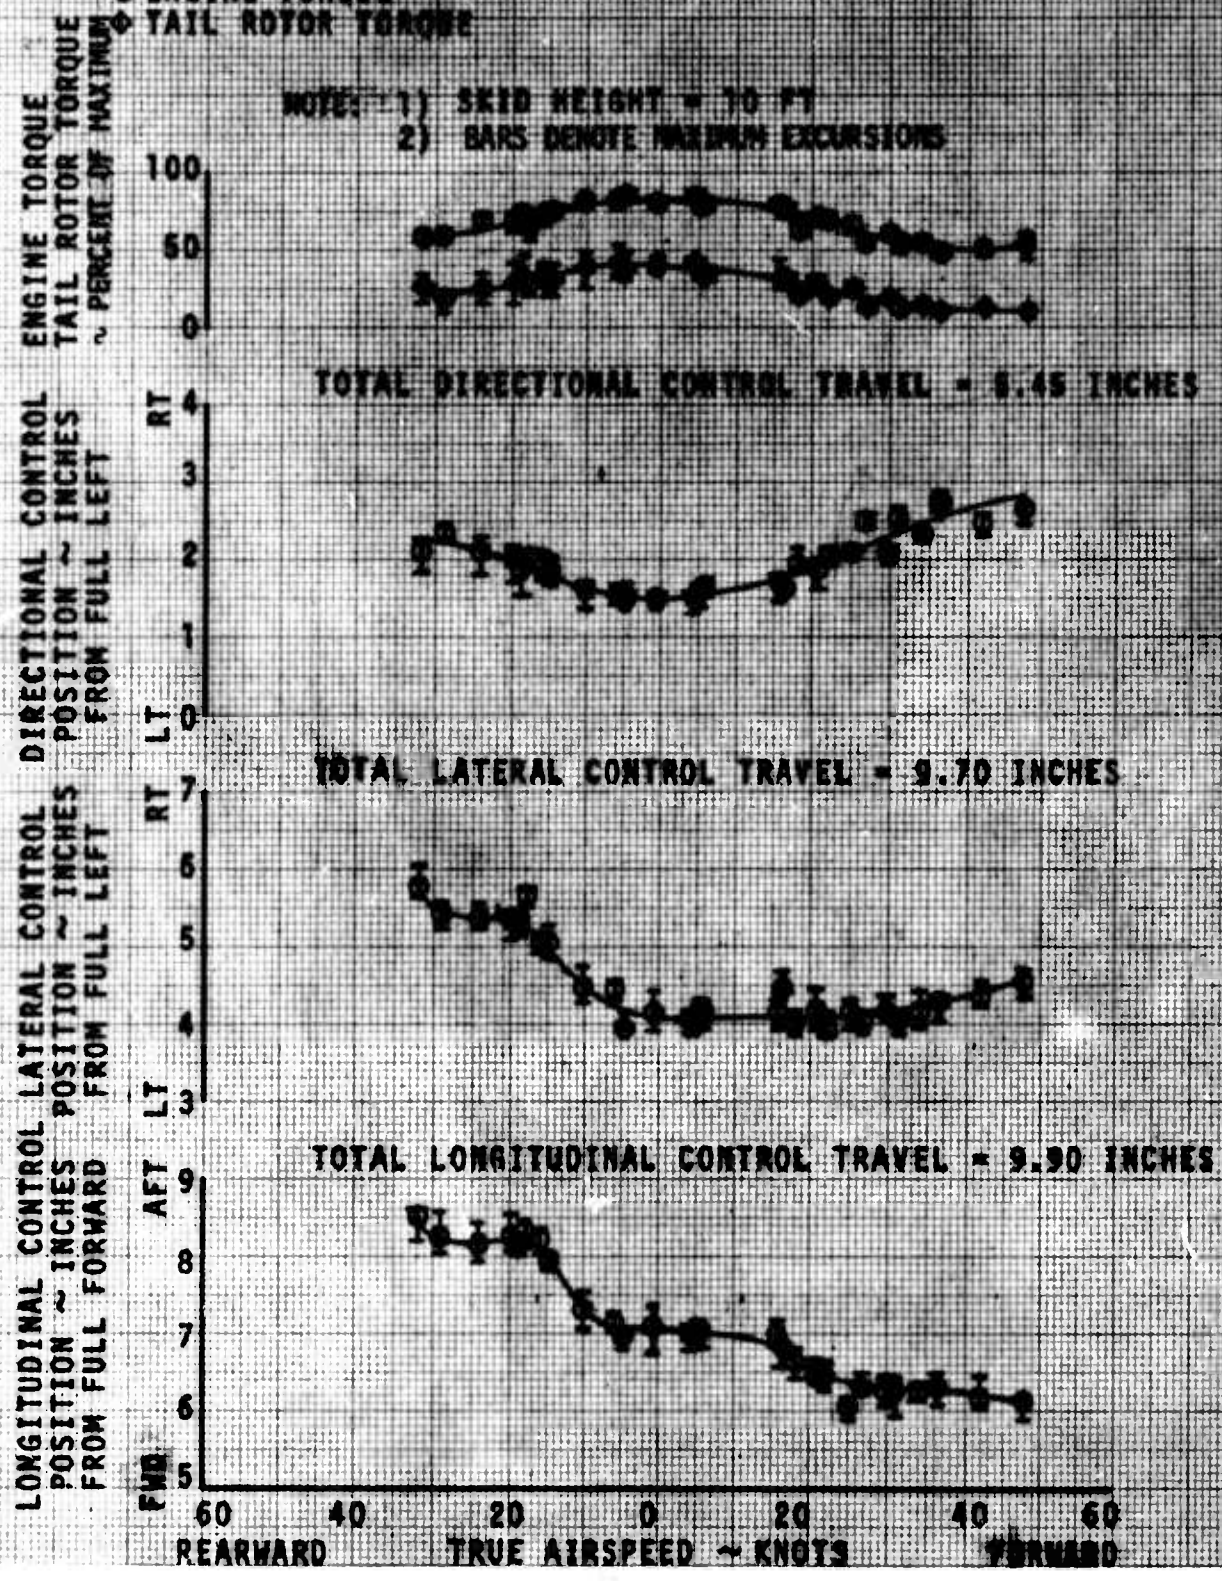
**FIGURE 35**  
**CONTROL POSITIONS IN SIDWARD FLIGHT**  
**YAH-1R USA S/N 70-15936**

The aircraft was stabilized at the following azimuths relative to the ground track: zero, 45 and 60 degrees (right headwind), 90 degrees (right side wind), 135 degrees (right tail wind), 180 degrees (tail wind), and 270 degrees (left side wind). For low-speed forward, rearward, and lateral flight data, only the wind velocity component along the applicable axis was considered. For other azimuth conditions, the true vector velocity of the relative wind speed was taken into account. Additionally, critical azimuth data were taken on three occasions by hovering in winds with velocities ranging from 20 to 24 KTAS. The data are presented in figures 34 through 46, appendix E.

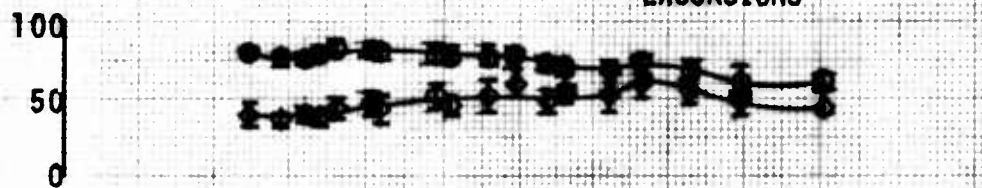
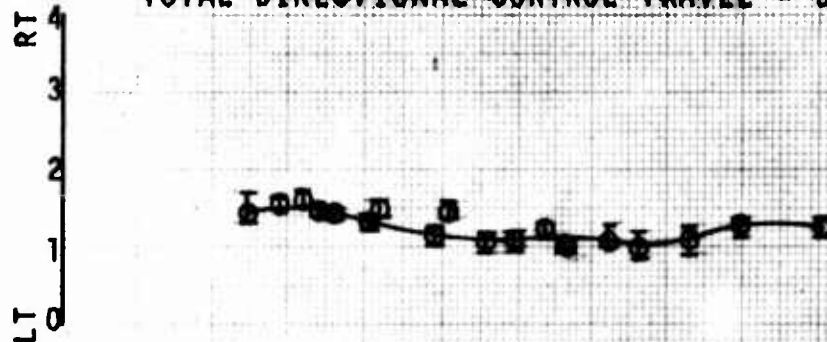
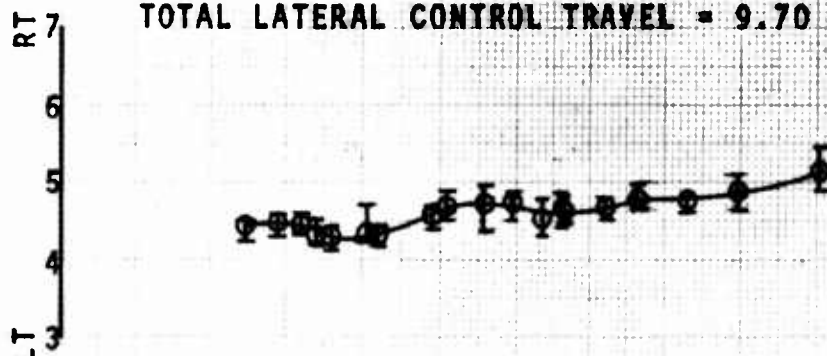
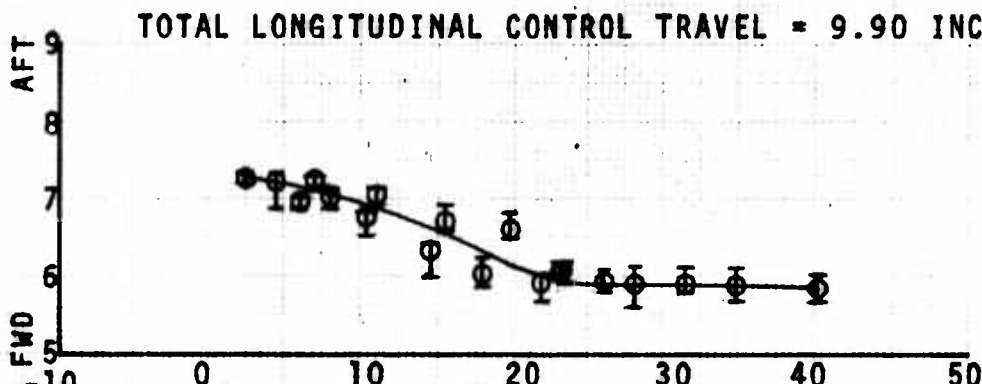
TOTAL DIRECTIONAL CONTROL TRAVEL = 5.45 INCHES

TOTAL LATERAL CONTROL TRAVEL = 9.70 INCHES

TOTAL LONGITUDINAL CONTROL TRAVEL = 9.90 INCHES

**FIGURE 37**  
**CONTROL POSITIONS IN SIDEWARD FLIGHT**  
**YAH-1R USA S/N 70-15936**

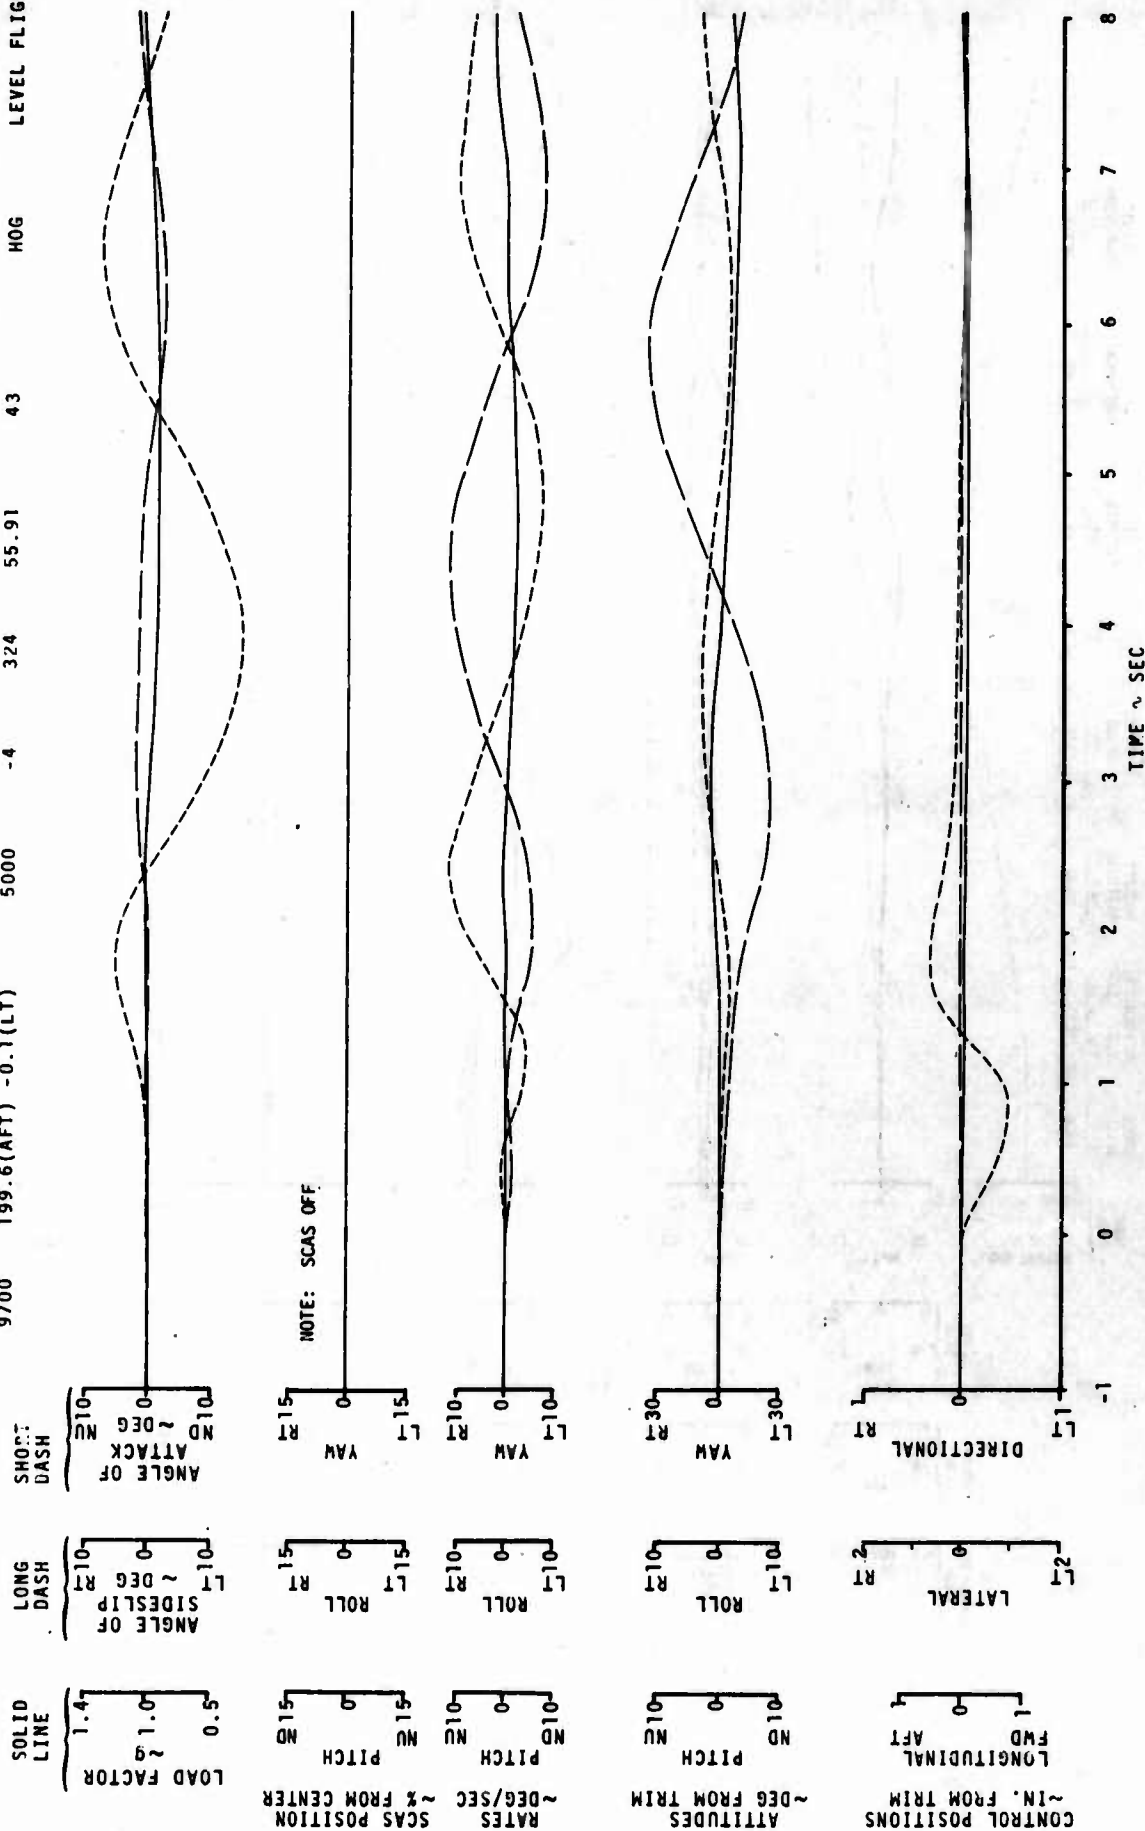
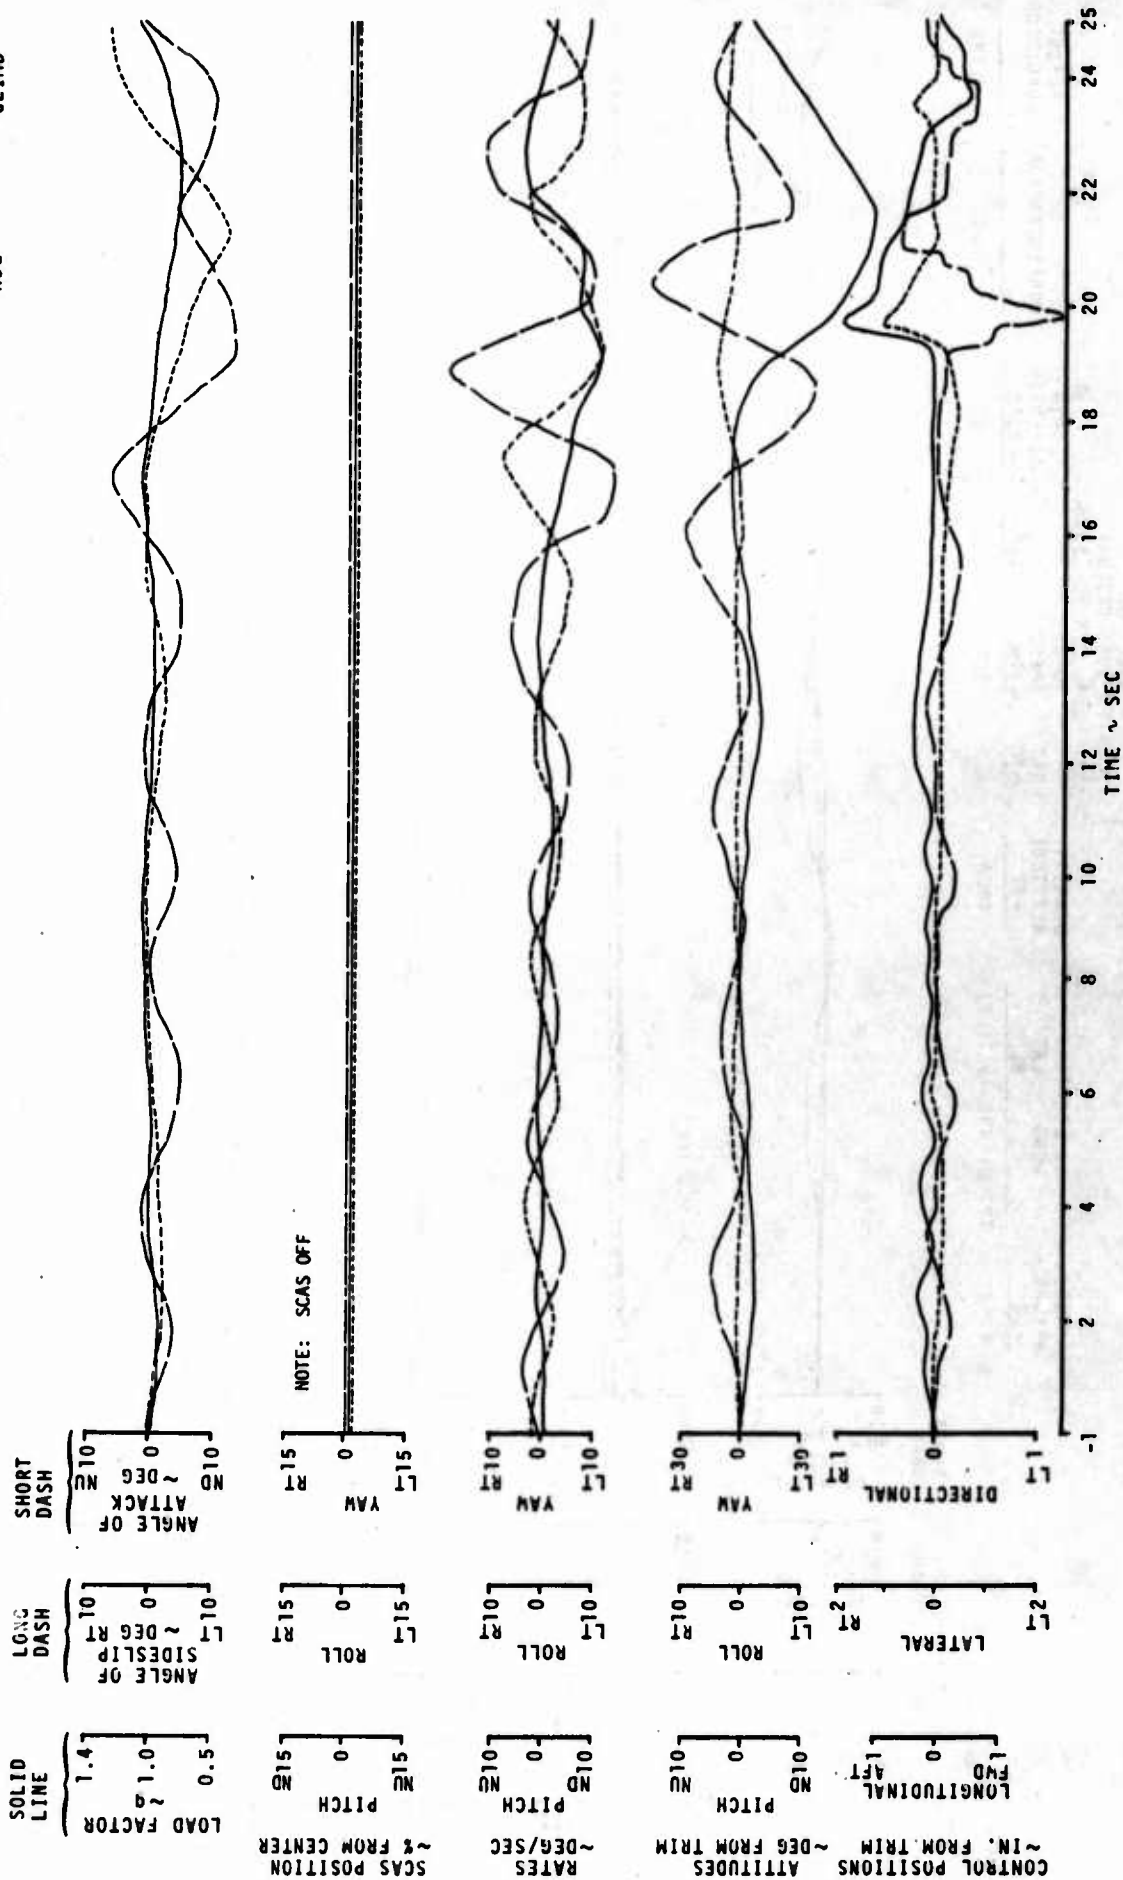
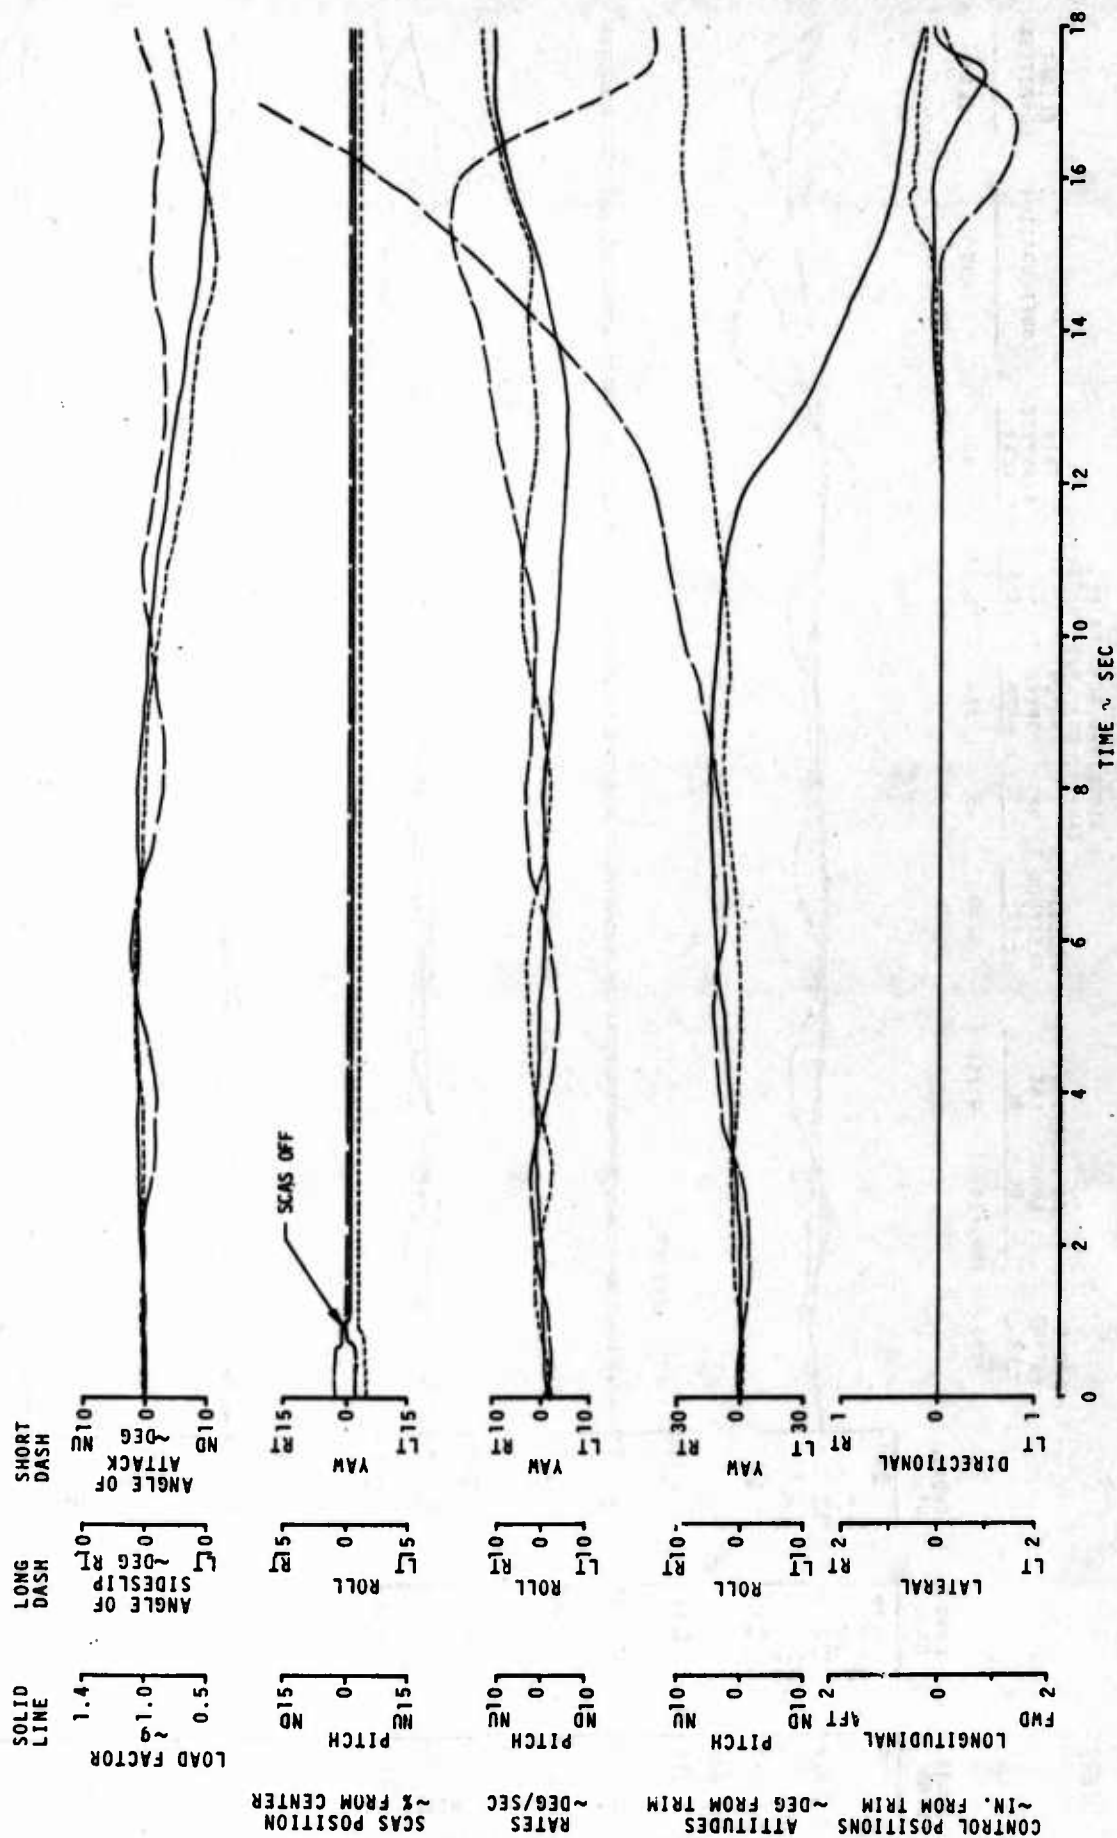
FIGURE 59  
SIMULATED SCAS FAILURE  
YAH-1R USA S/N 70-15936

FIGURE 60  
SIMULATED SCAS FAILURE  
YAH-1R USA S/N 70-15936

FIGURE 61  
SIMULATED SCAS FAILURE  
YAH-1R USA S/N 70-15936

78. Figures 59, 60, and 61, appendix E, are time histories of simulated SCAS failures at 43, 61, and 63 KCAS with maximum power (1290 shp). At 43 KCAS the aircraft responded to inadvertent pilot cyclic control movement and diverged in an oscillatory fashion, with a period of approximately 16 seconds. During this oscillation, pitch-to-roll coupling was evident by a nose-down pitch rate causing a right roll rate. At 63 KCAS and takeoff power, two distinct types of divergence were observed. Figure 59 shows a neutral lateral-directional oscillation in a maximum power climb with the pilot supplying the damping through cyclic control movement. When the pilot decreased his damping efforts, the aircraft diverged laterally and recovery was initiated in response to sensed roll accelerations. Recovery was positive and easily controlled; however, in conditions of restricted visibility or instrument flight, the roll accelerations would be extremely disorienting. The second and primary divergence mode is shown in figure 60. This mode was an essentially aperiodic divergence in pitch and roll, resulting in a nose-down pitch and a roll to the right. A left lateral cyclic input was made in response to the roll acceleration and the aircraft was allowed to roll to a bank angle slightly in excess of 90 degrees to the right. Recovery from this attitude was easily accomplished in visual flight conditions; however, under instrument flight conditions, a safe recovery would be extremely difficult. The divergent character of the SCAS OFF dynamics of the YAH-1R helicopter in a maximum performance
